BYLAW 14-32

A bylaw of the County of Vermilion River in the Province of Alberta to adopt the Area Structure Plan for Robinwood Estates (Lot 1, Block 1, Plan 1218TR in SE-33-49-1-W4M)

Robinwood Estates Area Structure Plan

Phase I Environmental Site Assessment (ESA) Of the Property at SE33-49-1W4M in the County of Vermillion River, Alberta

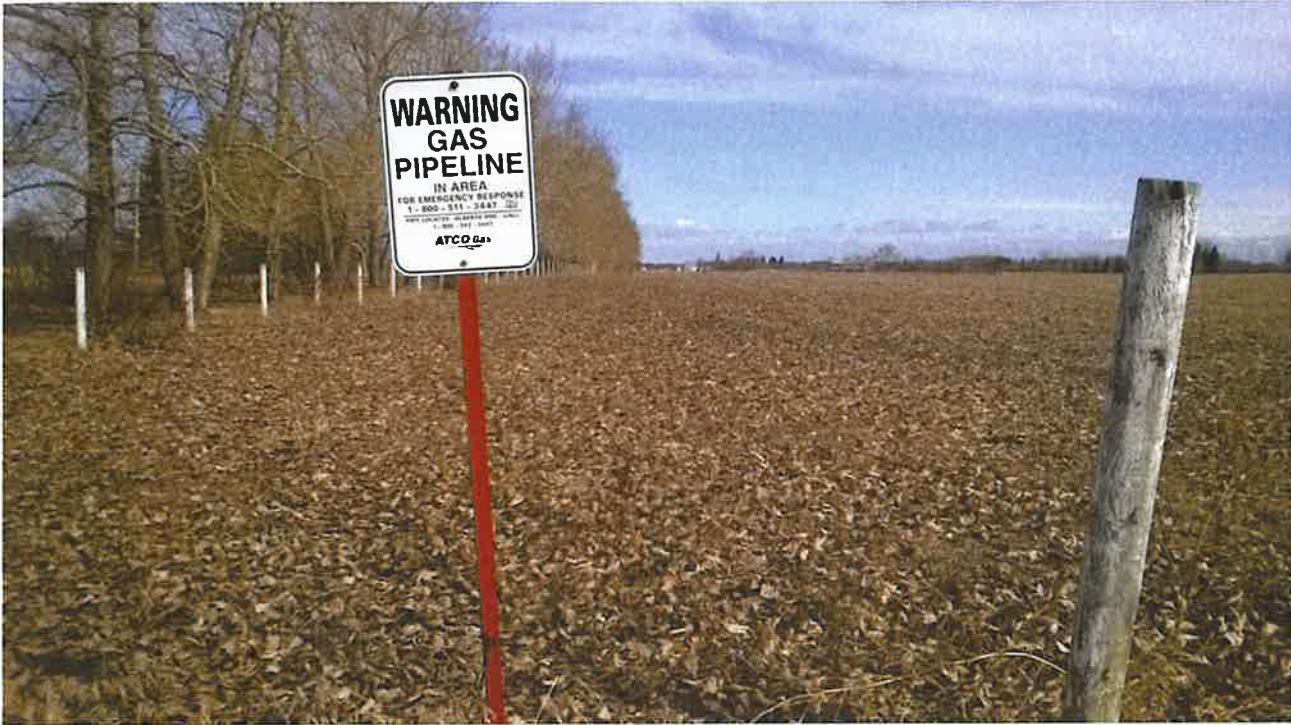
Photo 1: View of arable land from the southwest corner looking north. An Atco gas pipeline right of way.

A gas pipeline right of way was observed on the southwest corner of the Site and is assumed to run through the property. The pipeline was not evaluated as part of this investigation but should be properly assessed prior to any ground disturbances activities.

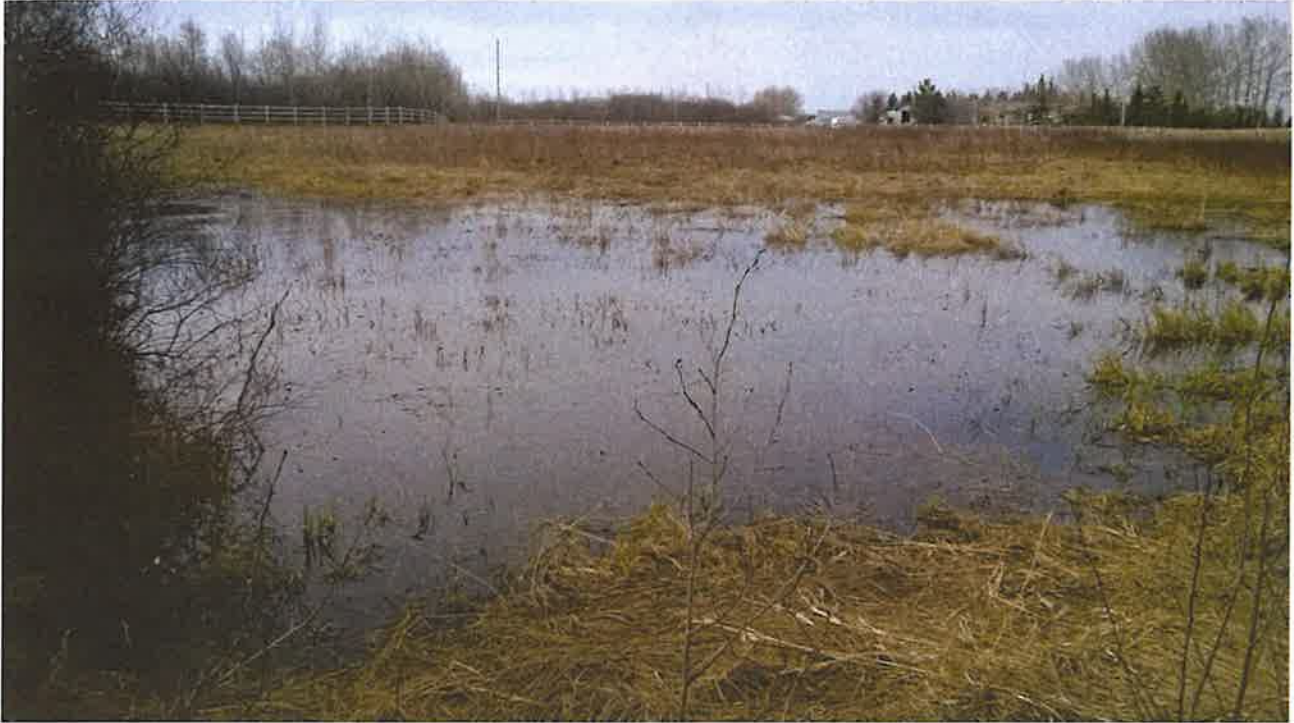
Photo 5: Wetland located in the southeast corner of property.

Several wetland features with standing water were observed within the Site. Two areas s in particular where noted in the southeast corner of the property and an altered unnamed creek was observed running through the approximate center of the property. It appears that the creek flows to the north (seen in *Figure 2*) but the channel was not easily distinguishable. The creeks features appeared to have been altered by historical agricultural activity on the Site and does flows into the neighbour's dugout on the north of the property. Flow continues to the northeast towards Lloydminster.

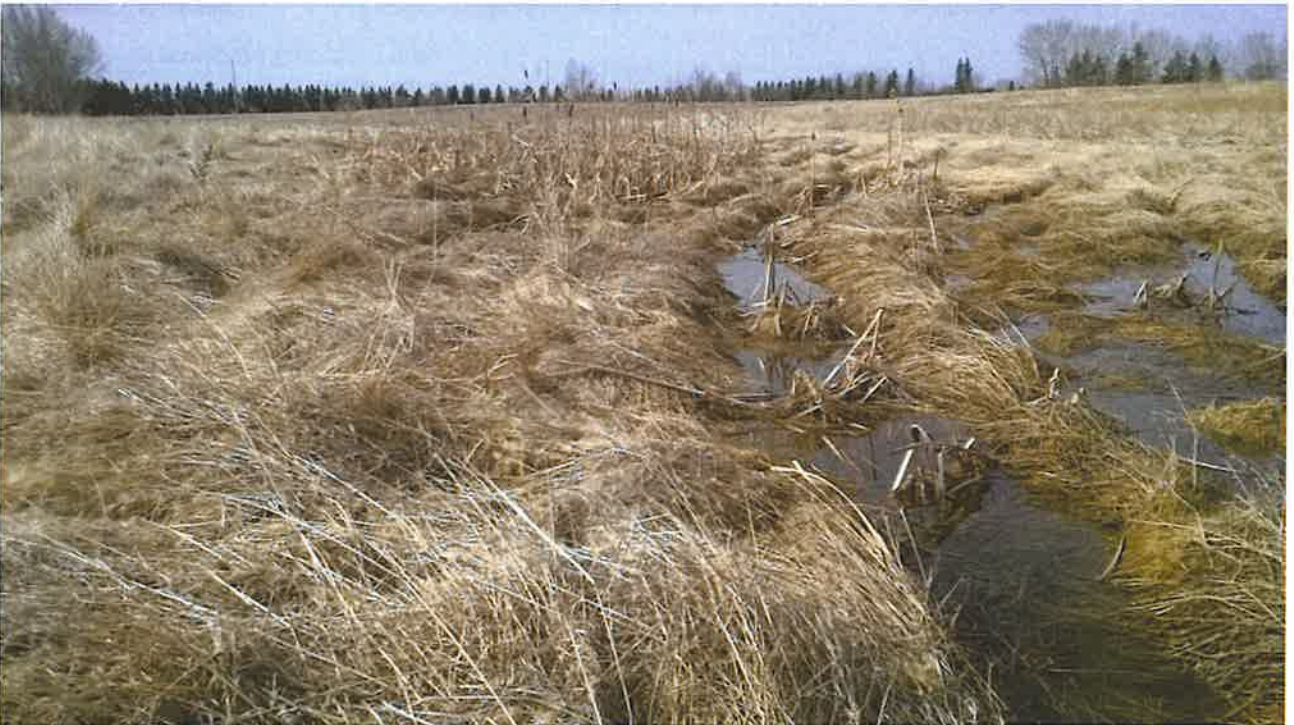
Photo 6: Creek running through center of the property flowing towards the north.

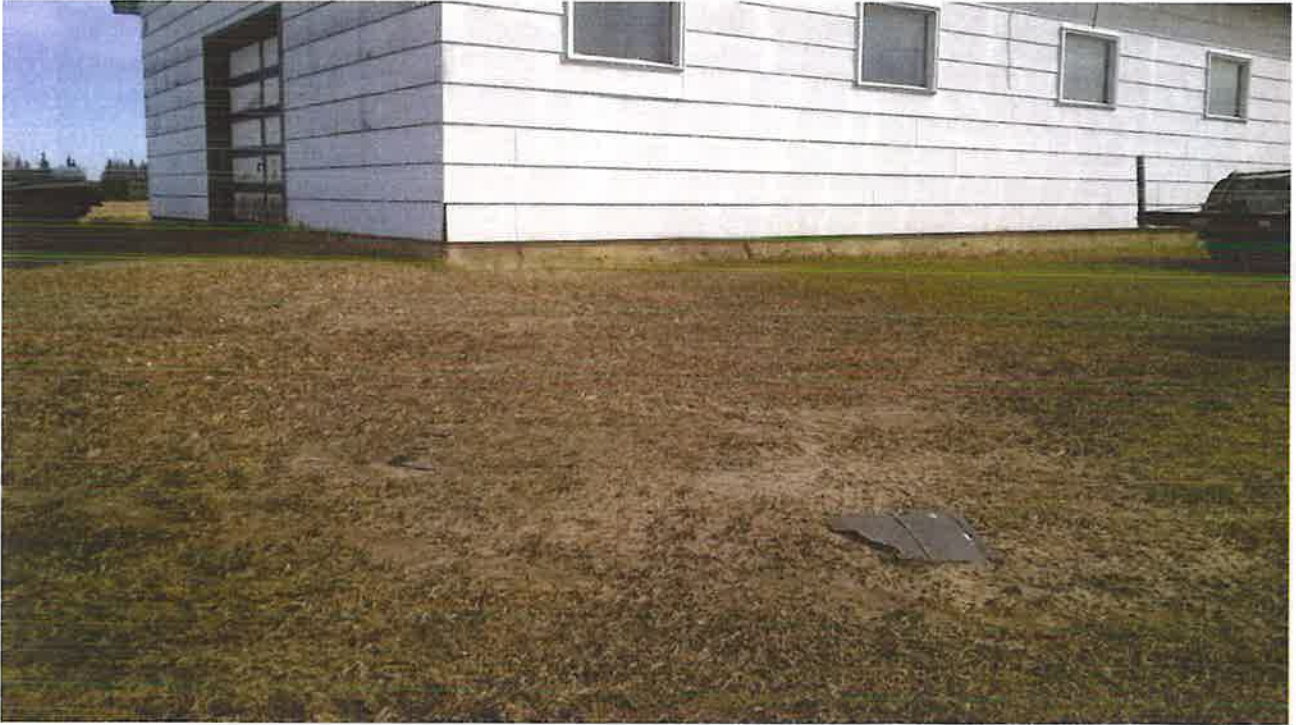
Photo 11: Area of stressed vegetation beside the barn.

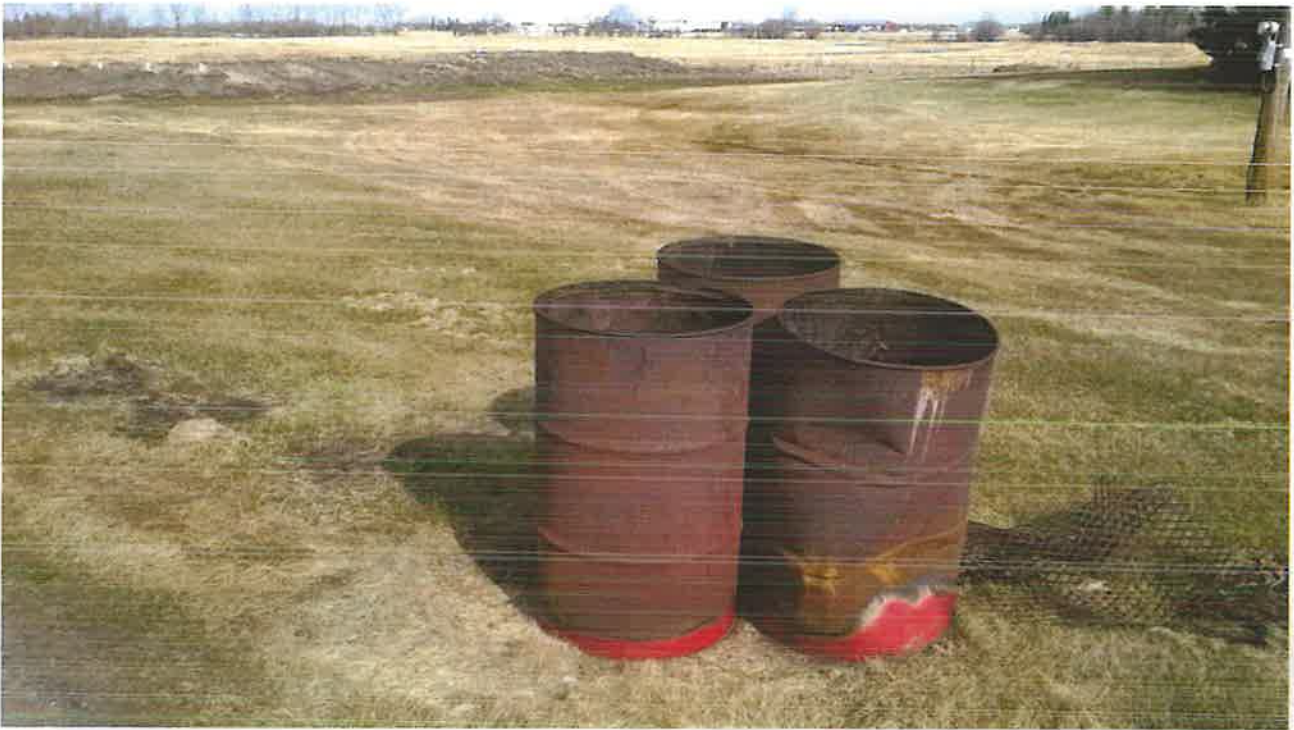
Photo 12: Garbage burn barrels along driveways with view of new septic field in the background.

Scott said that the household waste has been managed by using three burn barrels in the past and the current owners appears to be using the same waste disposal technique (photo 12). Scott also indicated that recently a new well had been drilled (prior to his father's death) as the former well had water quality problems. He remembered that the water would frequently be dark in colour and he believed that this was a result of suspected high iron content.

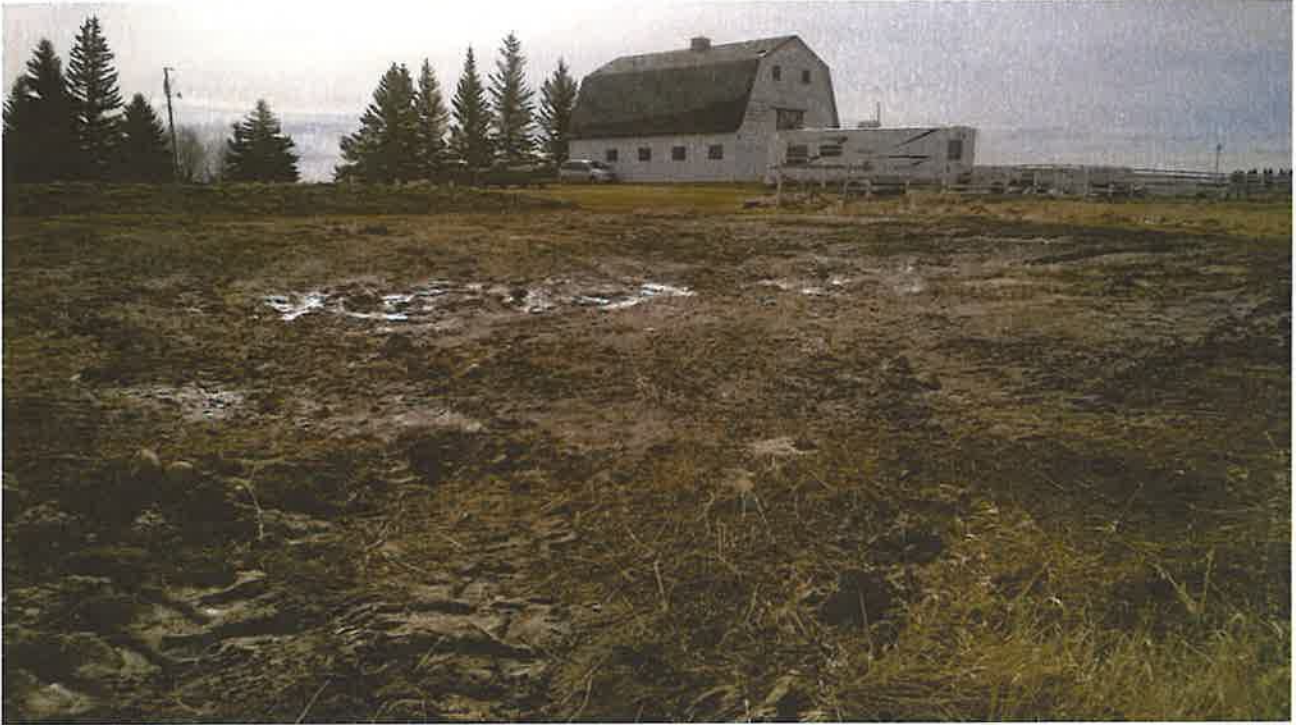
Photo 13: Area of cleared soil for new septic field.

The Site contains a septic field for the residence. Prior to the land being subdivided into three portions there was a septic field used by the original owner. Once the subdivision occurred the septic field was no longer located on the property of the house. Recently a new septic field was constructed and can be seen in photos (13 & 14). We recommend any and all decommissioning or reclamation shall be handled in accordance to the practices and procedures outlined in the Alberta Private Systems Sewage Systems 2009 Standard of Practice should development occur in areas where the current or former septic field are located.

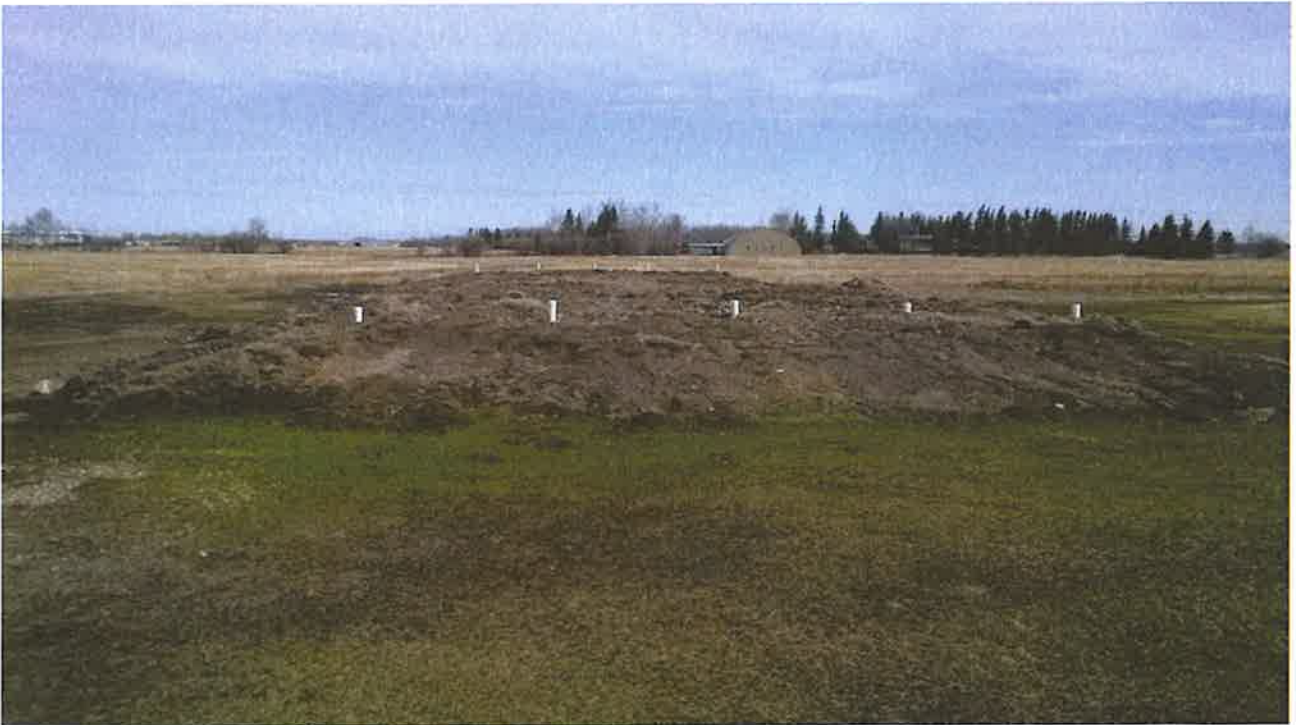
Photo 14: New septic field.

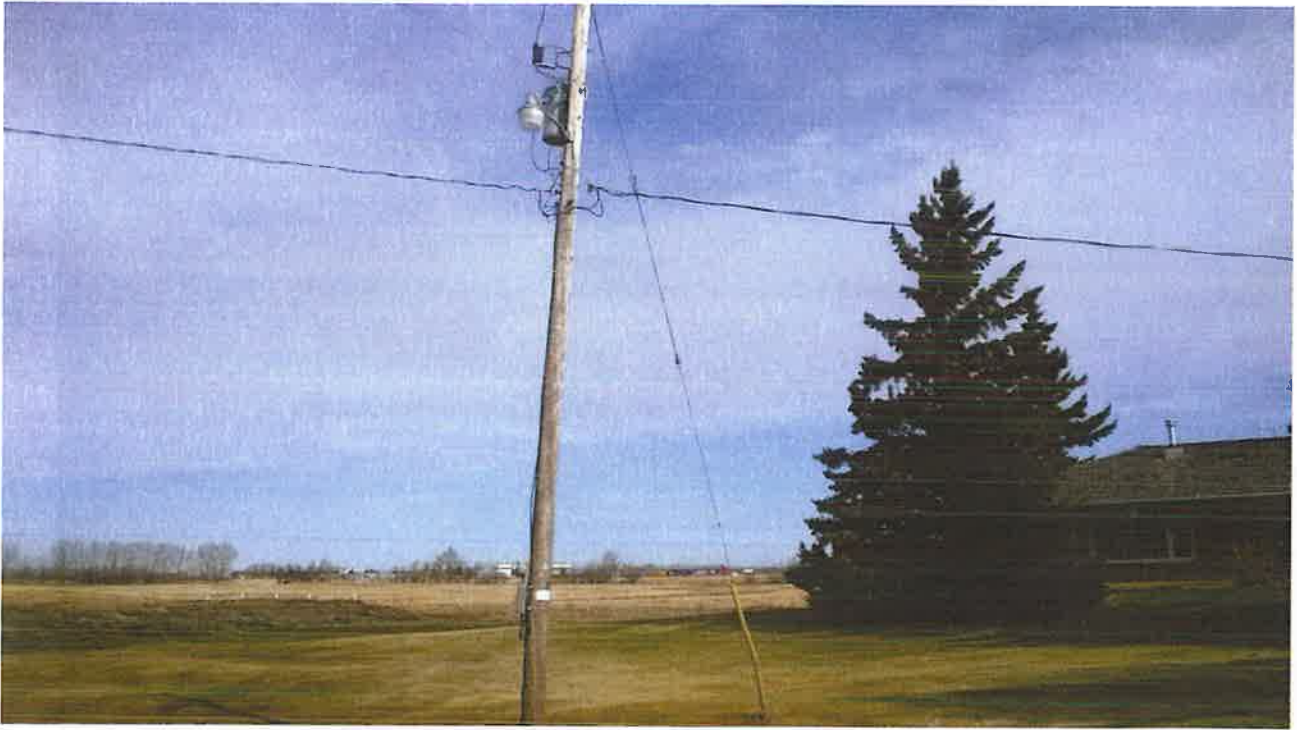
Photo 15: Power pole and transformer for residence.

ATCO Electric provides power to the residences in the area through a north-south three phase overhead power line along the east side of RR13. Conversations with ATCO electric indicate that there are no issues providing power to the subject site.

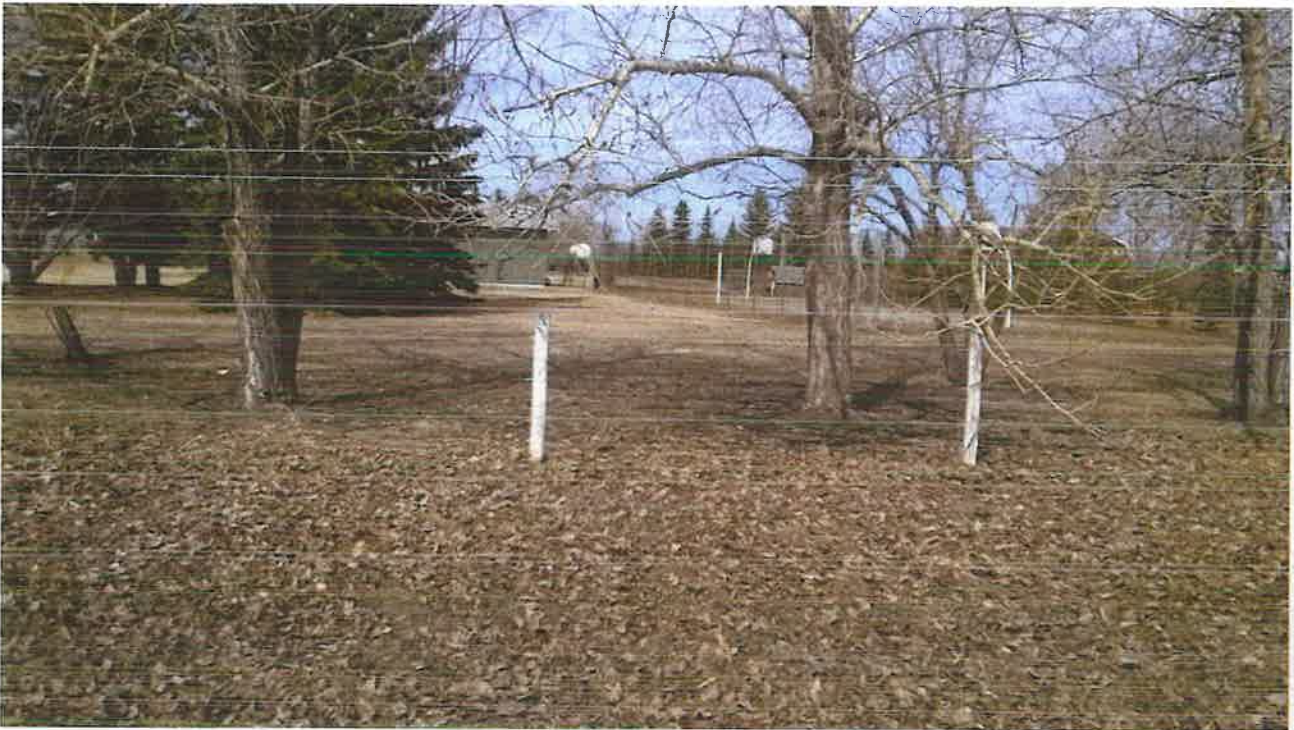
Photo 15: Above ground fuel storage tank on the neighbours property to the west.

Our observations and interview with the owner revealed no AST on the Site. However, during the site inspection a couple of ASTs on the adjacent properties were observed. AST's observed included: an above-ground fuel tank in the yard to the west of the property near the garage (photo 16). Across Range Road 13 on the Elk farm 3 ASTs were observed near the out buildings. One was a horizontal cylindrical tank approximately 10,000L in size and the other two were identical conical white vertical tanks. It is suspected that either fuel or propane is stored in the horizontal tank for use in the farm operation. Both neighbouring tanks are not considered an environmental concern based on their distance from the proposed development on the Site. To the west the tank is approximately 100 m away, to the east the tanks are approximately 300 m away from the proposed development.

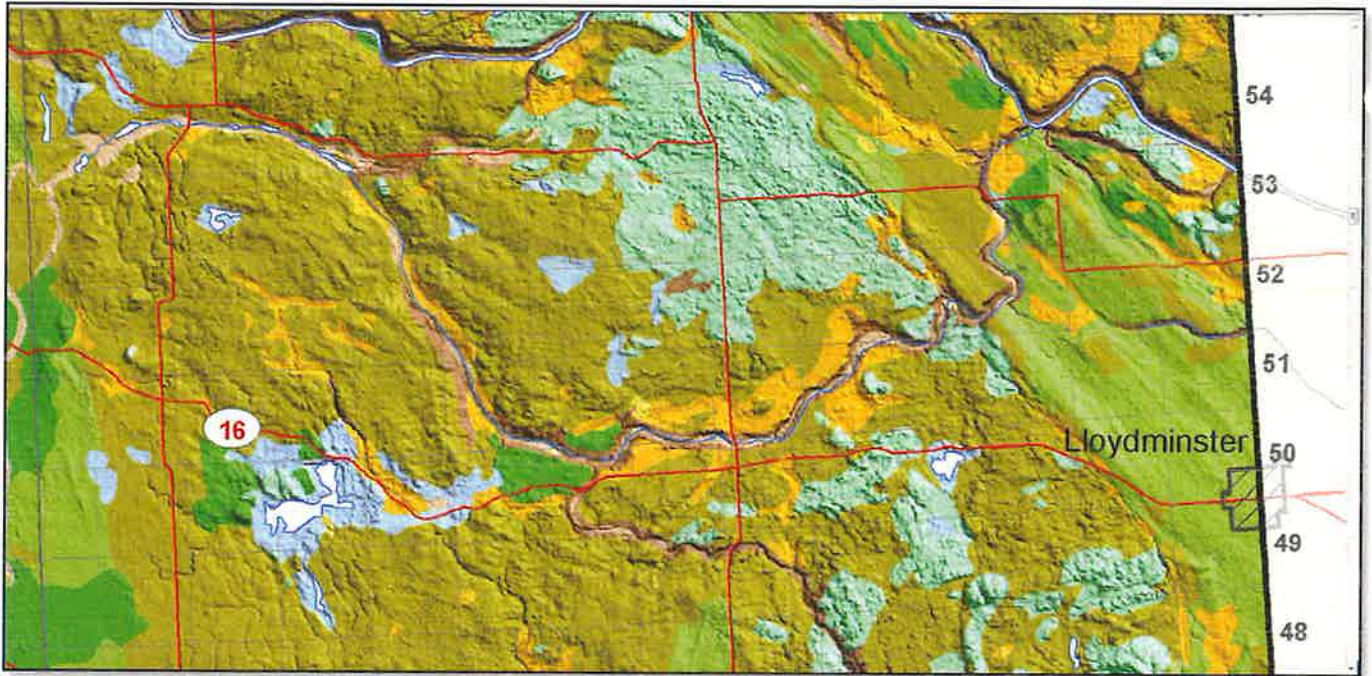
Figure 3 Regional Surficial Geology map maintained by the Alberta Geological Survey shows one soil type within the Site.

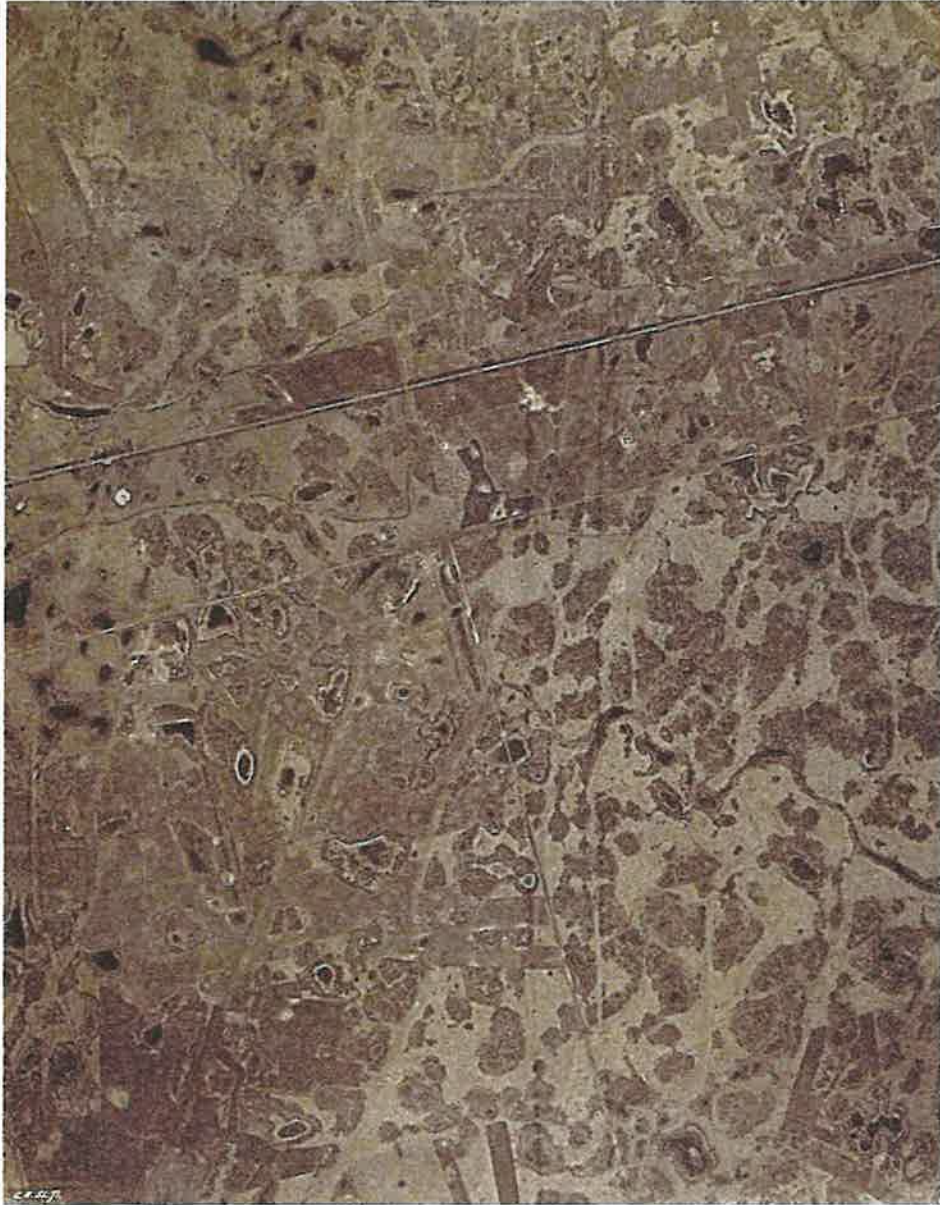
Figure 5. Aerial Photo 1924

The Site and surrounding area appears to be mostly undeveloped aspen parklands with roads or railway visible.

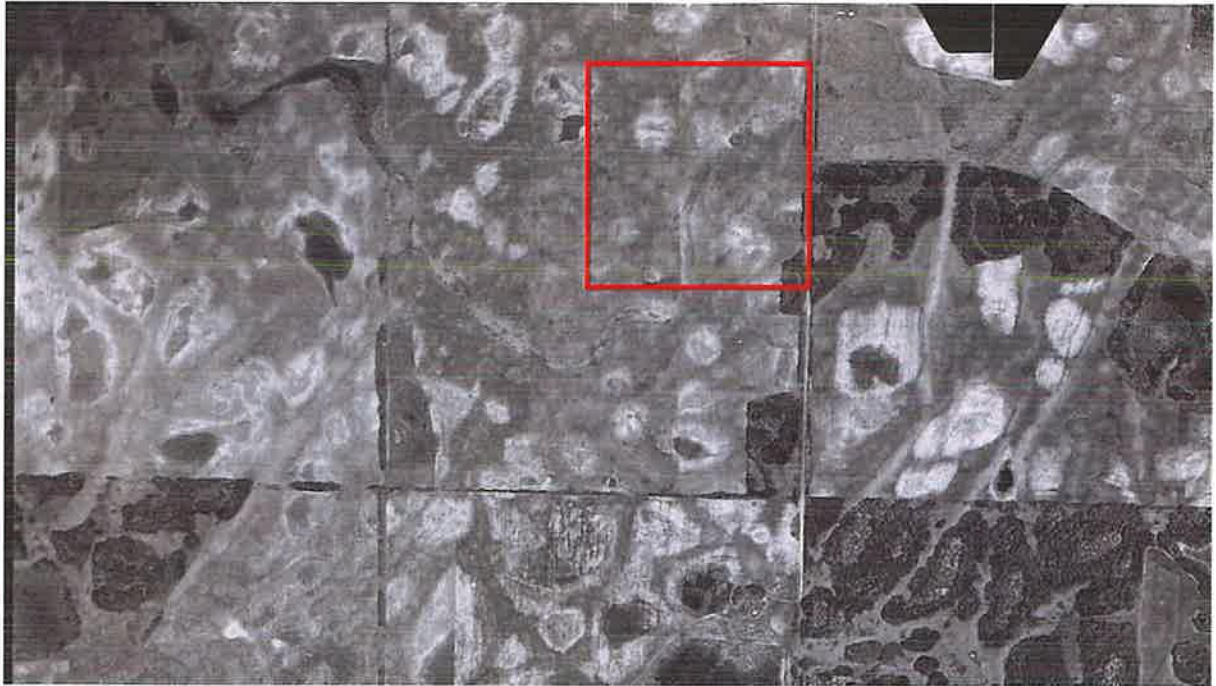
Figure 6. Aerial Photo 1950

The Site is mostly cleared of trees and shrubs with the creek running through the center. The surrounding properties also appear to be mostly farmland with small stands of woodlands.

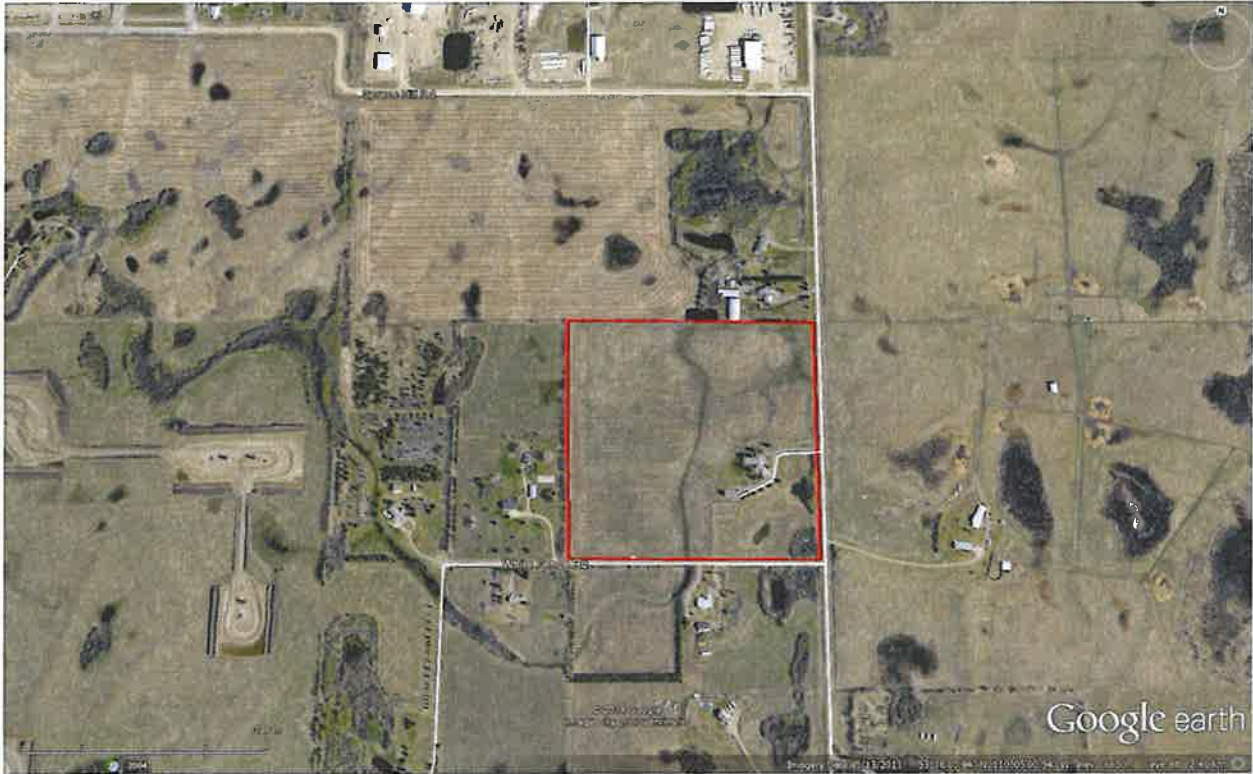
Figure 11. Aerial Photo 2004

New building and drive way visible on the perimeter of the Site to the N side.
